**NORTH DAKOTA
DEPARTMENT OF TRANSPORTATION**

Experimental Study ND 94-07

**Scoping Edge Drains with
an Optical Camera**

Project IM-8-094(005)331

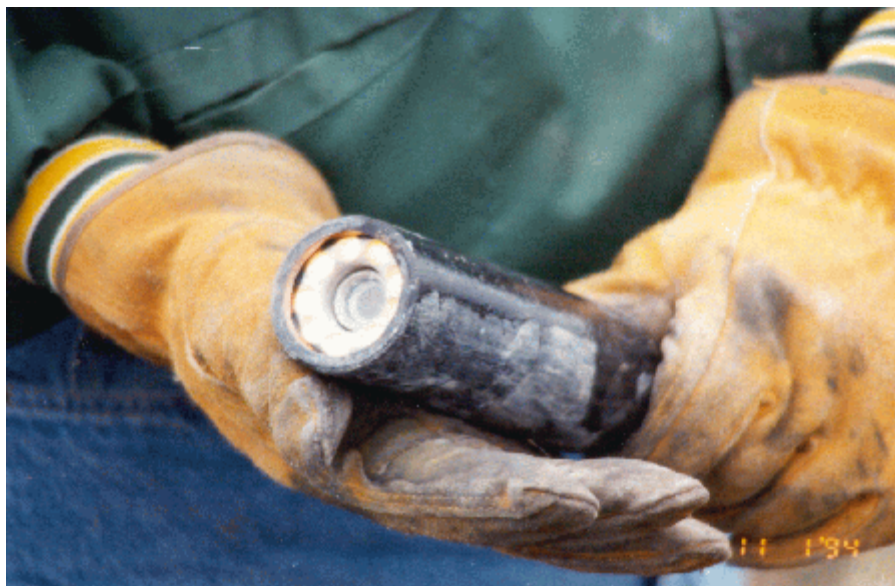
Photo 1: View of the P217 color optical camera.

Photo 1 depicts the P217 color optical camera. The diameter of the camera is about 1½". This enables the camera to enter into pipes that are small in diameter, such as the 4" edge drain pipes. It can also be used on larger diameter pipes when equipped with skids. This camera is equipped with several small lights that make a ring around the camera lens. The camera is designed to give high quality pictures with a minimum of light.
